The Mahoning Valley Mushroom Farm North Lima, Ohio AMD Investigation

Department of Geology and Environmental Science
The University of Akron
Theresa McQuade

Ohio Department of Natural Resources
Division of Mineral Resources Management
Cheryl Socotch

April 15, 2013

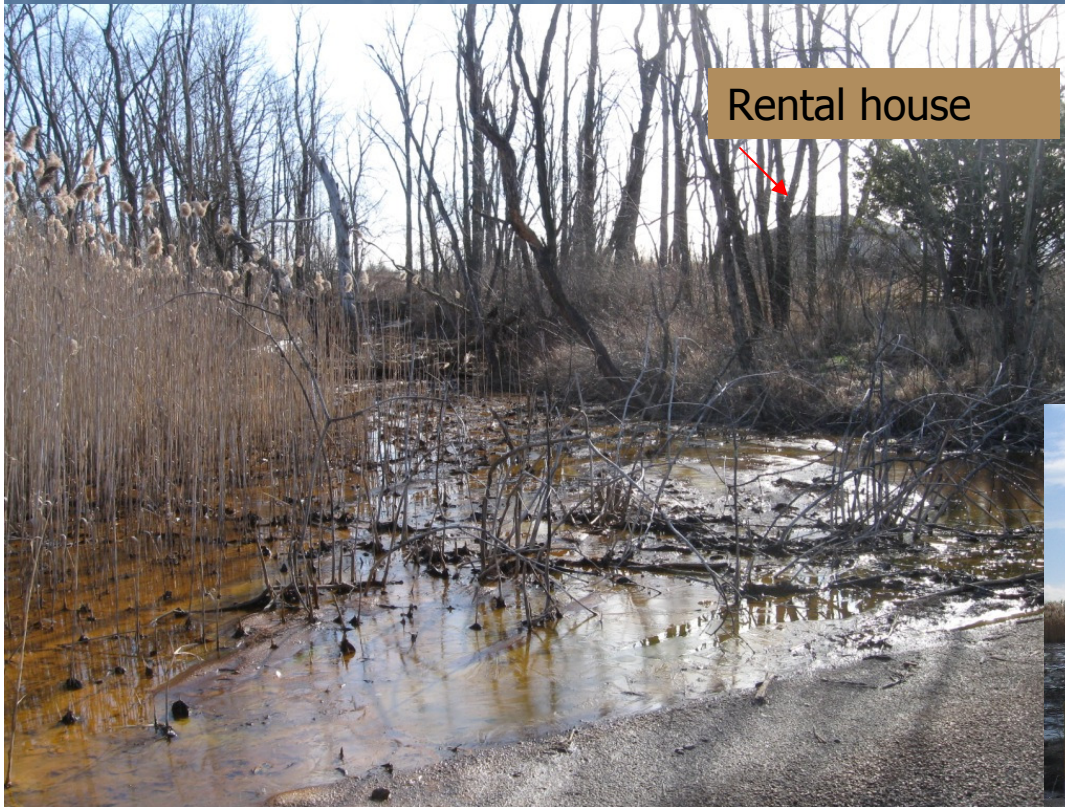
Rental house

Pre-existing drainage east of house

Pre-existing AMD seepage west of house

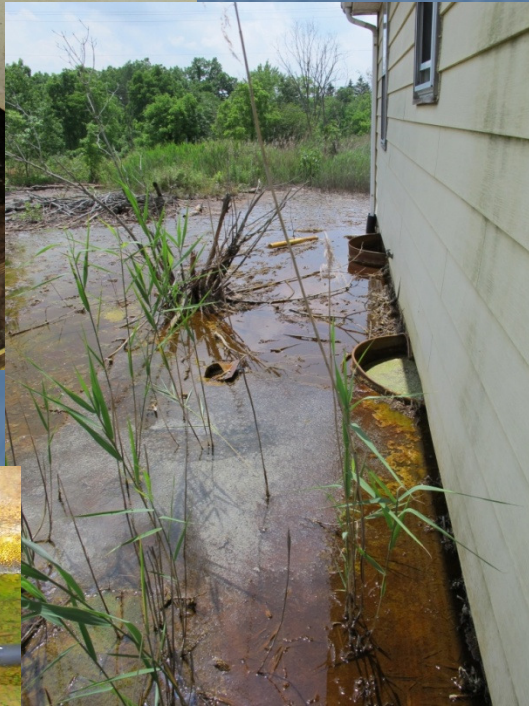
Laminar AMD flow from basement

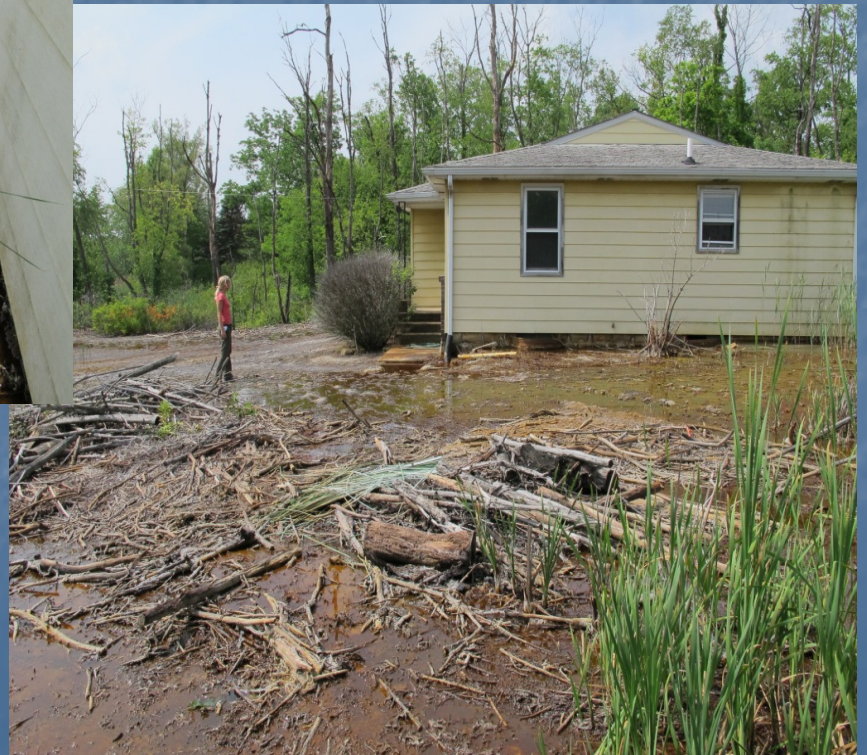
Wetland across access road – under SR 164

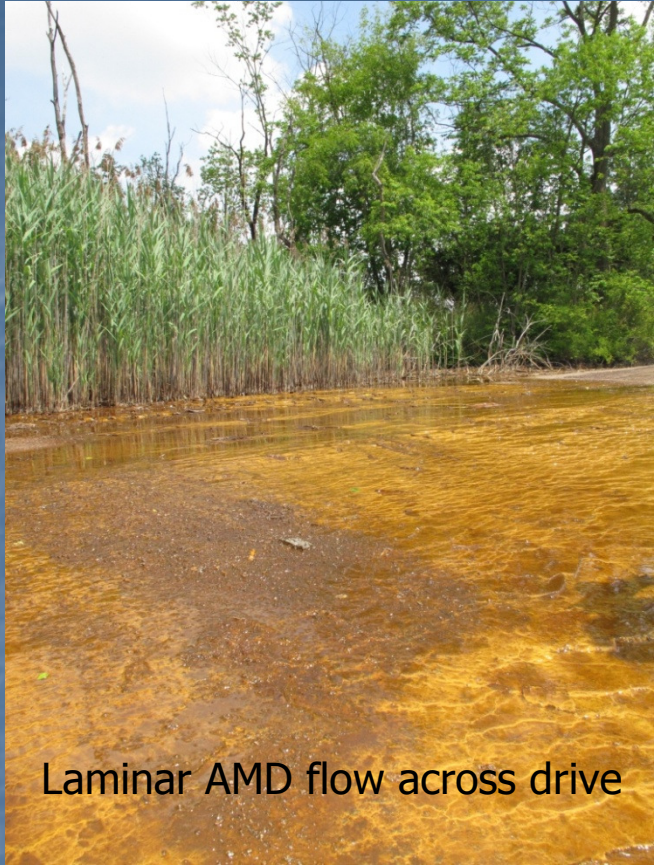
Laminar AMD flow across drive

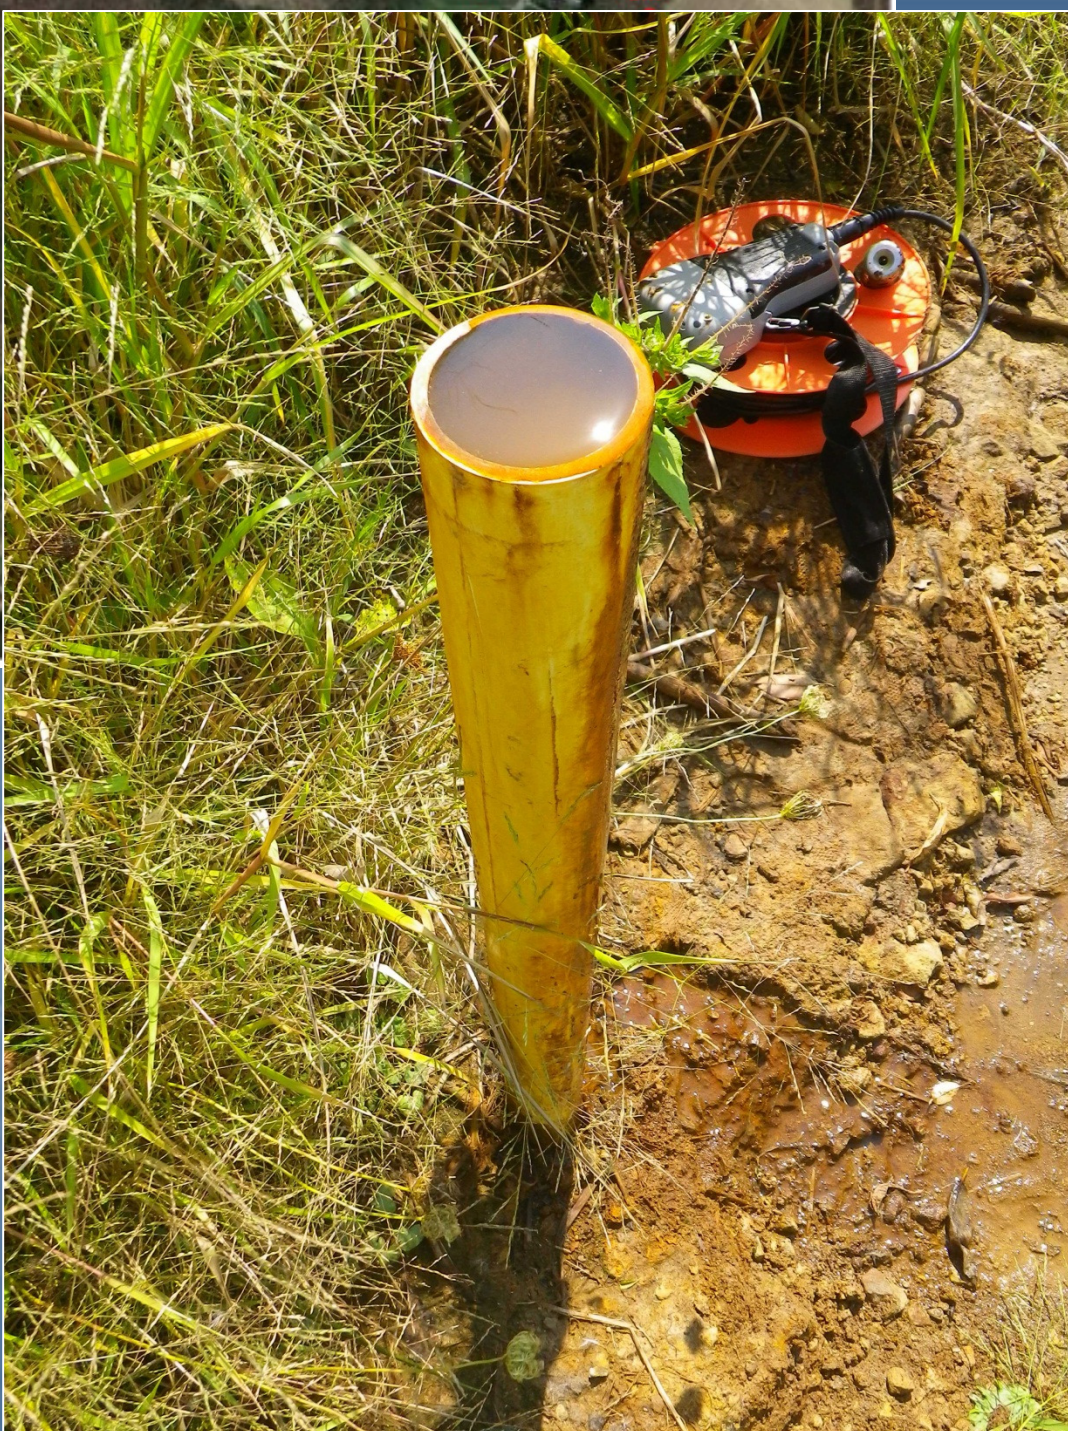
Artesian Wells!

BH11

elevation=1115 ft.

brown silty sand
to dry ss

saturated brown ss

open void ending
at underclay

TD=1090 ft

BH1

elevation=1112 ft.

brown silty
clay

clay

TD=1099 ft

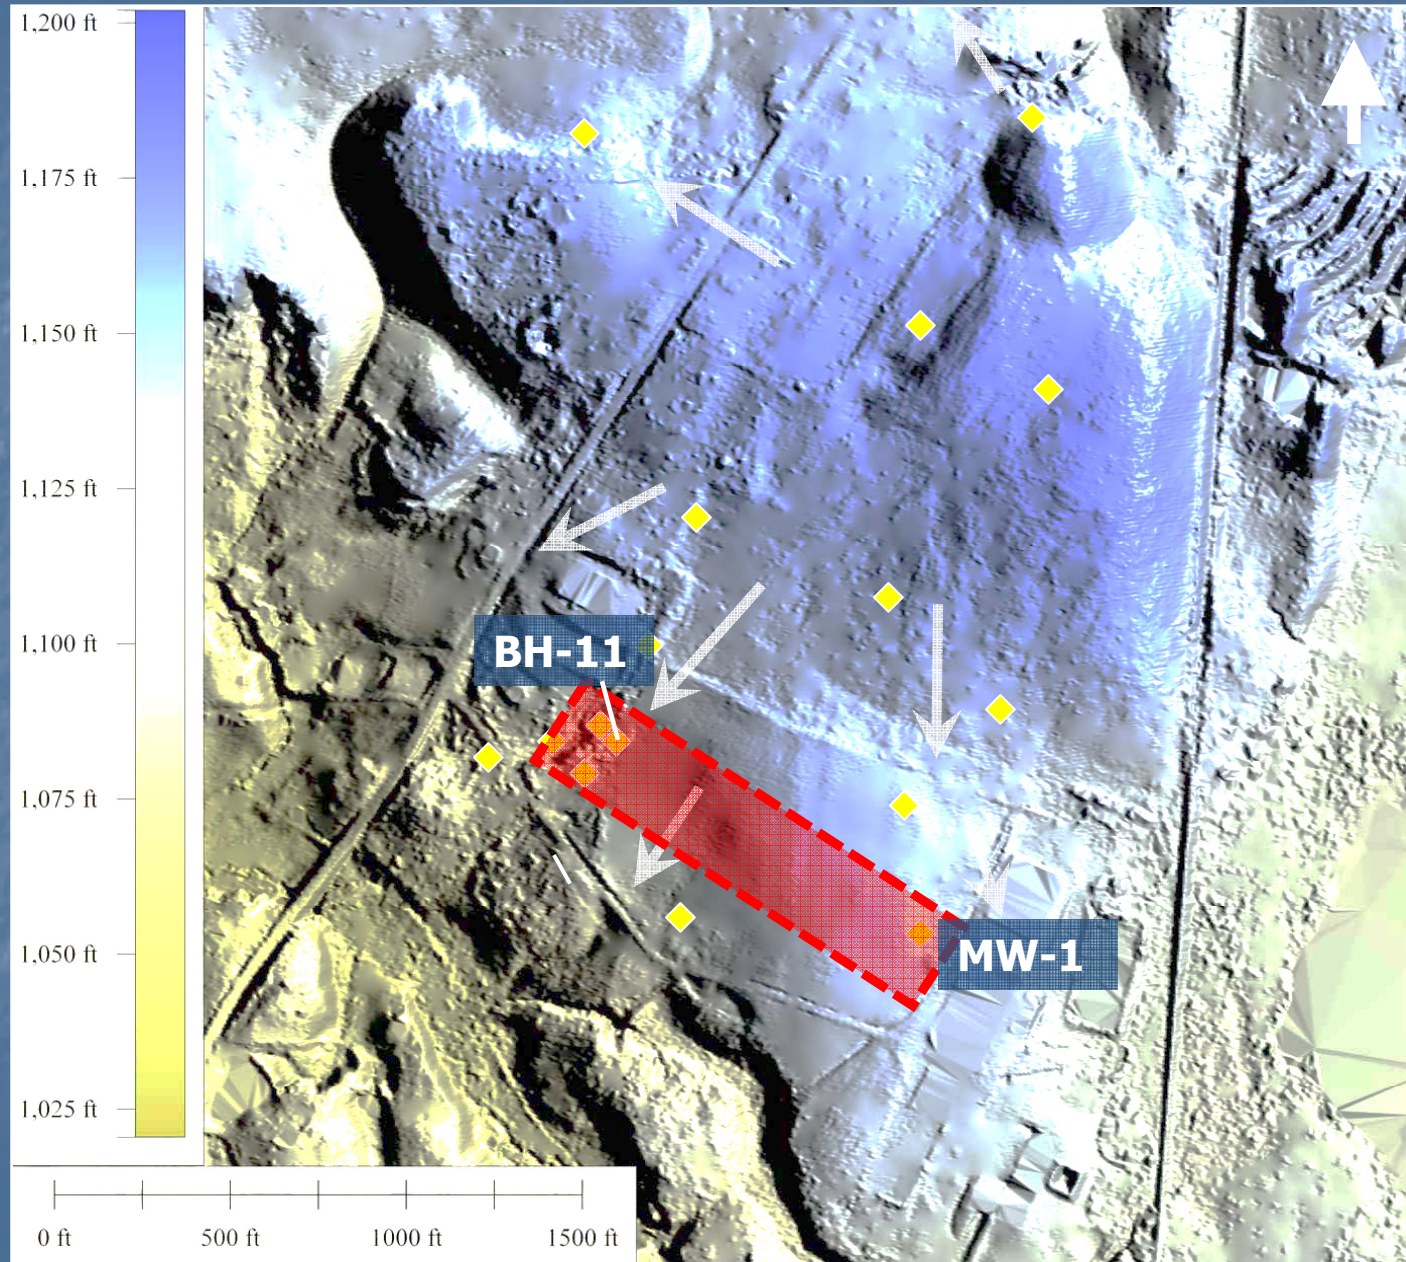
Abandoned Underground Mine

A. Mushroom Farm Site, North Lima, OH

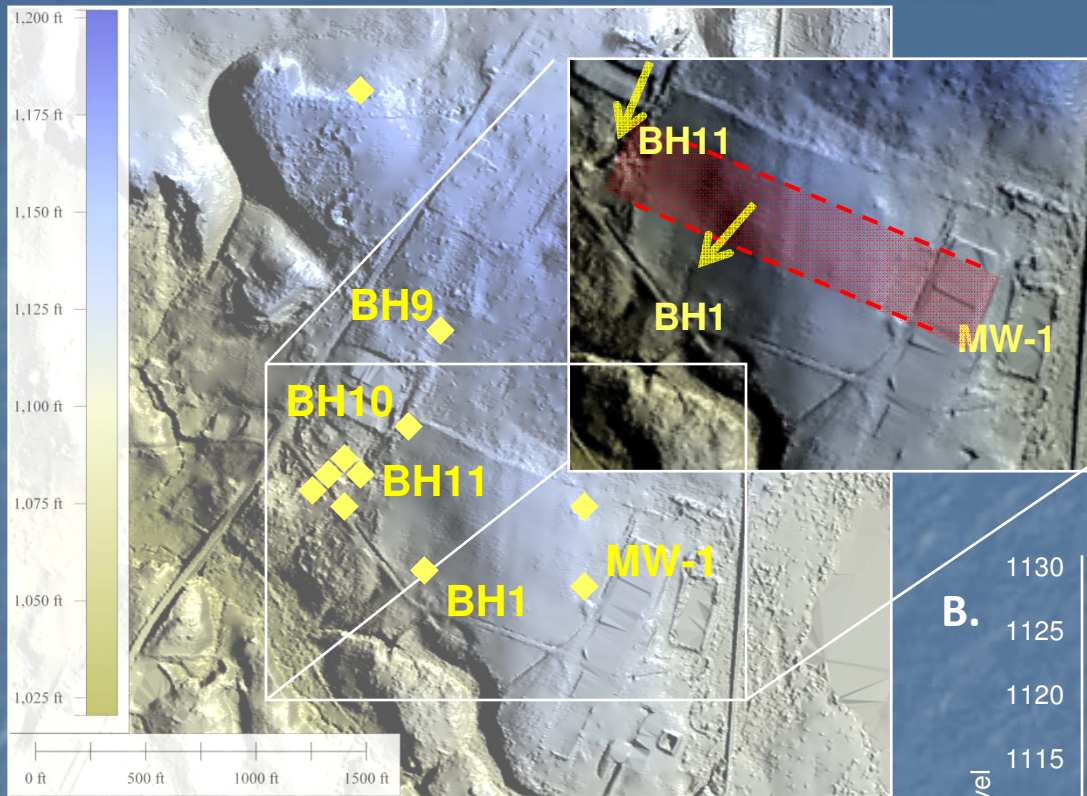
Potential AUM location
GW flow direction

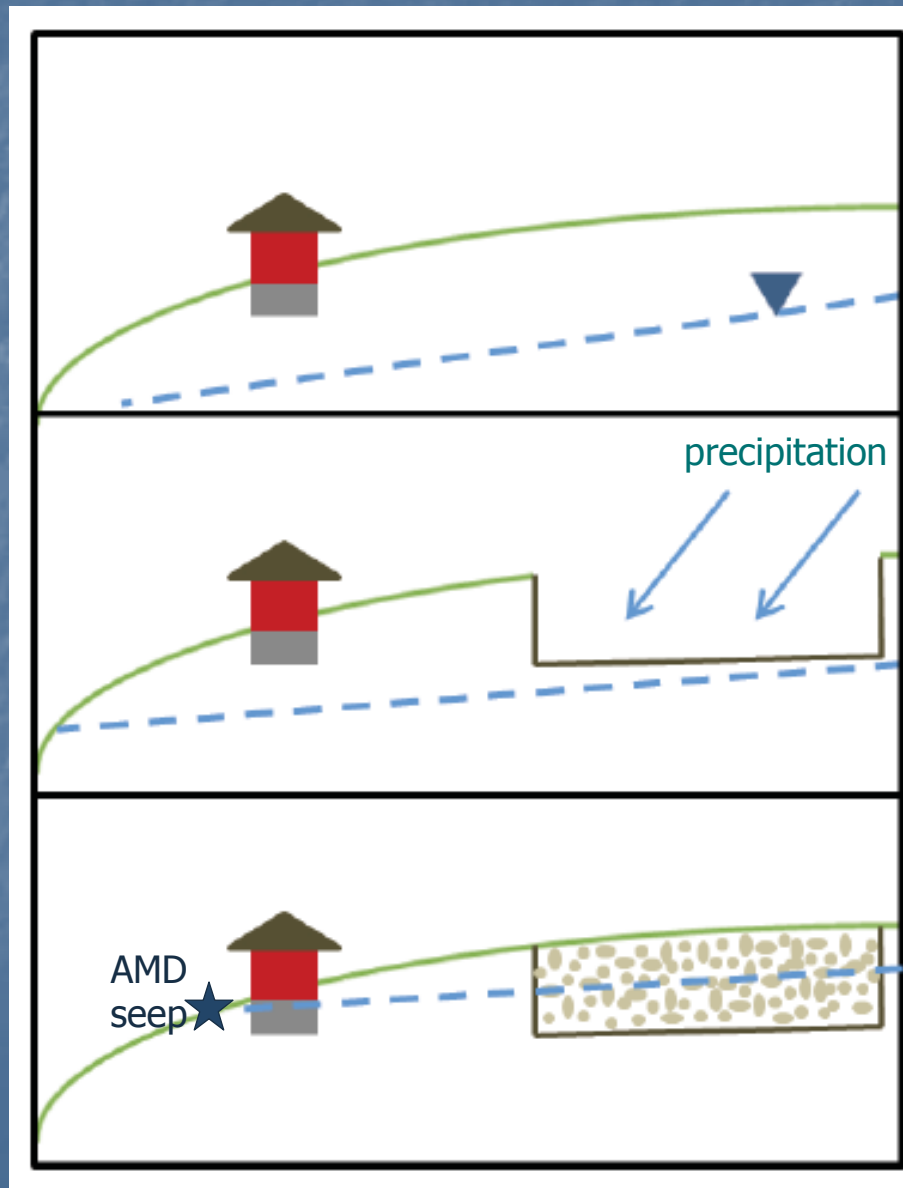
Change in Infiltration and Permeability

- Radial groundwater flow pattern
- Geochemical signature for AMD coming from the mine void established at BH11, BH1, window, and stream
- AMD discharging around the house = most severe
- Mine void connects BH11 and MW-1, possibly contains some amount of refuse
- AMD discharging is a direct result of change in surface infiltration
